The partial collapse of the Bridge Galeria dos Estados in Brasília, DF, Brazil

1 Abstract

The partial collapse of the Bridge *Galeria dos Estados* occurred on February 6th, 2018, in Brasília, Brazil when blocked the strategic traffic of downtown. Accessing the central bus station came to a complete stop, vitally impacting the commercial, banking and hospital sectors, and Government Administration District of the capital. The viaduct was built for the inauguration of Brasília, in February 1960, exactly 58 years ago. With 5,000 m², the viaduct has 8 spans with dimensions of 21.70 m and 27.0 m. The partial collapse of the viaduct suddenly occurred without large deformations, or other evidence visible to the naked eye, which could indicate, in advance, the fragility of the structure. The investigations indicated stress-corrosion on all prestressed cable the cap beam. The corrosion is systematic damage that occurs in all seven bent of the bridge. The structural retrofit of the bridge makes removals and reconstruction of the cap beam, easy for maintenance. Finally, the partial collapse could have been avoided if there was any visual inspection possibility, of reasonable cost, which wou

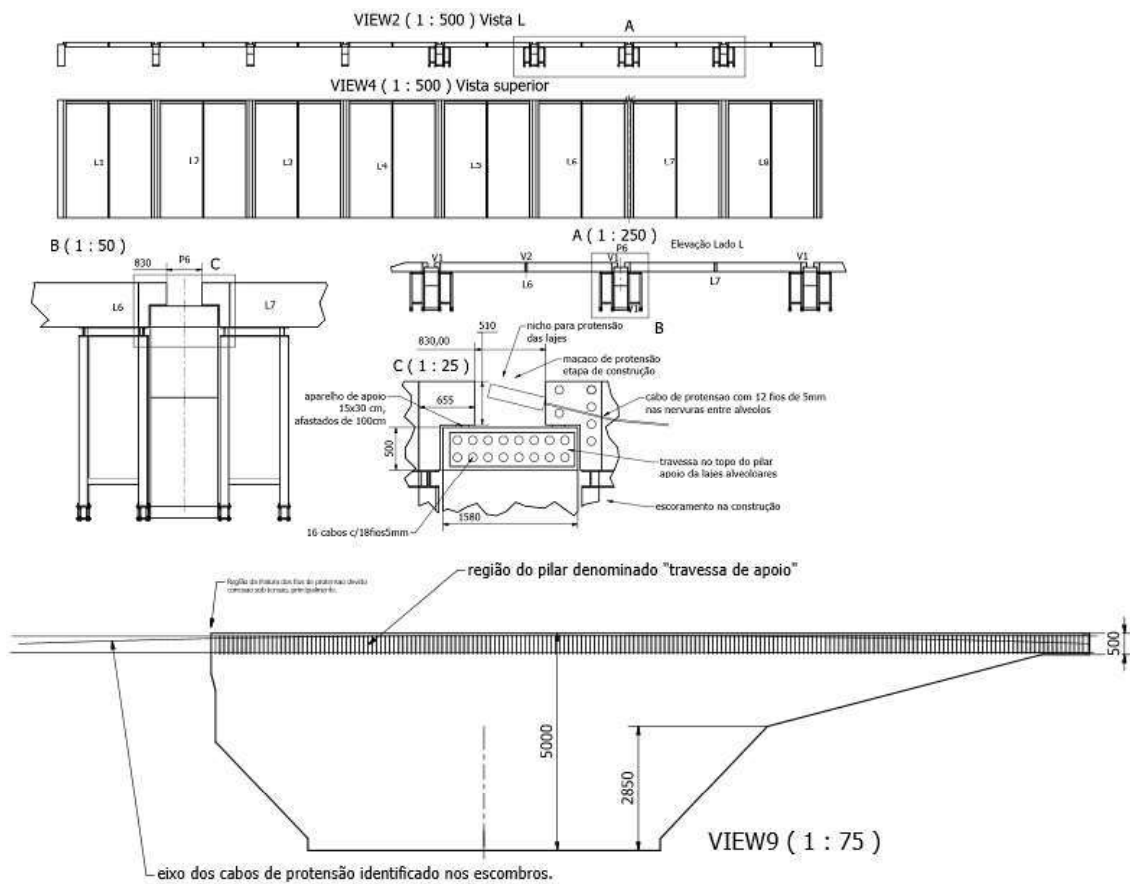
Then this space between the slabs, of 83cm, was filled with simple concrete, forming a prismatic bar with a cross-section of 54x83 cm, which occurred 7 times along the viaduct, figure 2. Therefore, in the upper view, the bridge formed a finished and continuous surface with a slightly curved axis. It can be verified that the pictures were taken after the collapse.

Figure 2 Design developed after dissection of the parts of the collapse, aiming to clarify aspects of the system of prestressing structure, Source: Authors

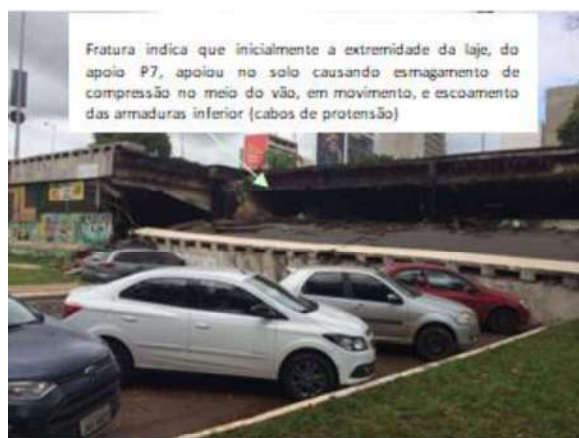
It is verified that under the spans of the bridge, between the columns P5 and P6; P6 and P7, there was a restaurant installation that it blocked the vision of damage to the structure.

In addition, the P7-P6 section was used for public parking. In this way, 4 vehicles were crushed when part of the structure collapsed and fell on them, Figure 3.

Figure 3 - Situation of the spaces underneath the viaduct, Source: public

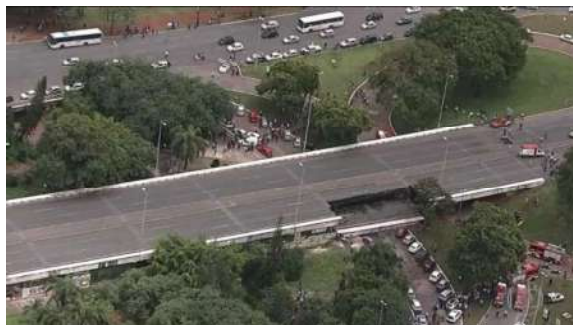
It is observed in Figures 4 and 5, that there was partial collapse delimited by the fractures of the wingspan of the columns P7 and P6, in this order, which resulted in a well-delimited cutout of the

bridge bearing track, Figure 4, of them. In this case, it is relevant to consider the danger that the vehicles were subjected in those moments followed by partial collapse.

Figure 4 - Upper view of the viaduct instants after partial collapse, source: public

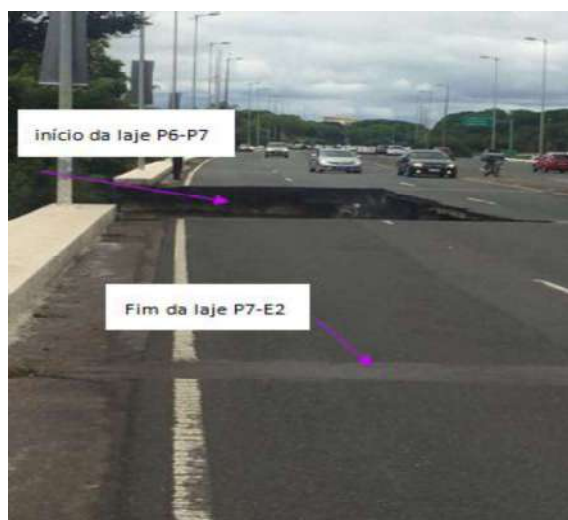
Figure 5 - Partial collapse of the deck, Source: public

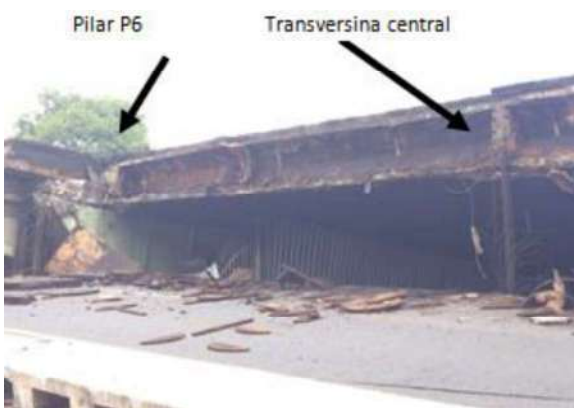
The shear reinforcement occurs only in the support of the "slabs", cap beam, with a limited height of 50cm. It is armed by stirrups, involving the 16 prestressing cables. In the case of the P6 pillar, the fracture process occurs in various plans., figure 6.

Figure 6 - Lateral view of the collapsed part, Source: Public

The resistance of the support was initially ensured by the presence of the 16 cables, until the beginning of the stress corrosion. When the behavior of the corbels is modified, with the opening of cracks in the region of 7.3 m from the edge of the slab, side L and W side. However, it is noteworthy that these cracks would only become visible after completely crossing the cap beam at 50 cm high when it was possible to identify on the free lateral face of the columns. The visualization of the initial cracks was hidden by the articulation of the Gerber beam of the slab. These cracks grown without being able to be identified in time to avoid the partial collapse of the wing of the pillar. It is noteworthy that there are not projects of these structures in NOVACAP.

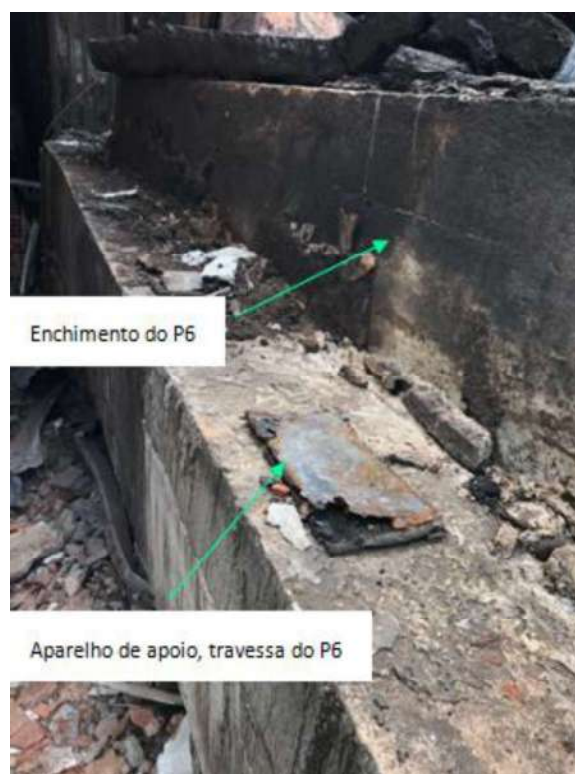
These images show the bearings with 150x300x30 mm (it was estimated 3 cm thick due to the advanced state of degradation of the device) that were installed on the upper face of the prestressed cap beam at 15 cm from the end.

When the investigation of the collapsed part was initiated, it was possible to identify a large part of the reinforcement of the parts. It was also possible to investigate the crossbeams of the slab at the ends and in the middle of the span, V1 and V2, respectively, figure 7.

Figure 7 - Cap beam, bent P6, where it can be identified the slab bearing device, source: Authors

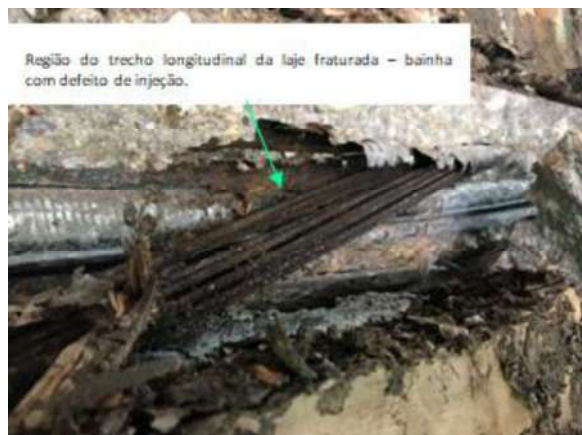
Figure 8 - P6-P7 span sheaths photo, where it can be identified sheath without injection, Source: Authors

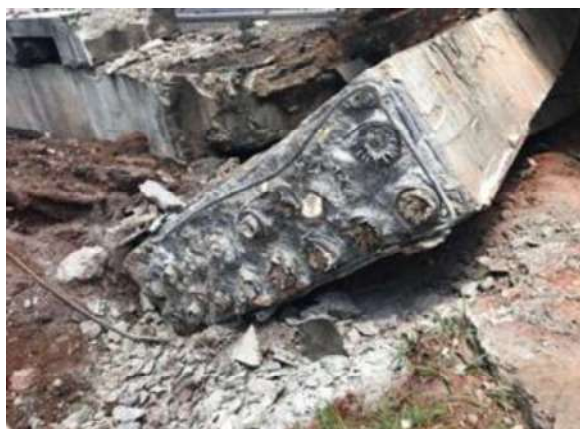
The corrosion was aggressive in the cables of the prestressed cap beam, mainly in the region of the ends, where they were aligned to increase the efficiency of the prestressing reinforcement, i.e. Seeking greater eccentricity of the cable, has showed in the Figure 9, where the cables tangent to the stapes of the fractured section are found.

Figure 9 - Detail of the cable anchors in the end section of the cap beam, P7, with 16 cables, with 18 wires of 5 mm in each, Source: Authors

2. Stage II, considered the intermediate phase when cracks occurred in the prestressed parts of the deck, figure 9.

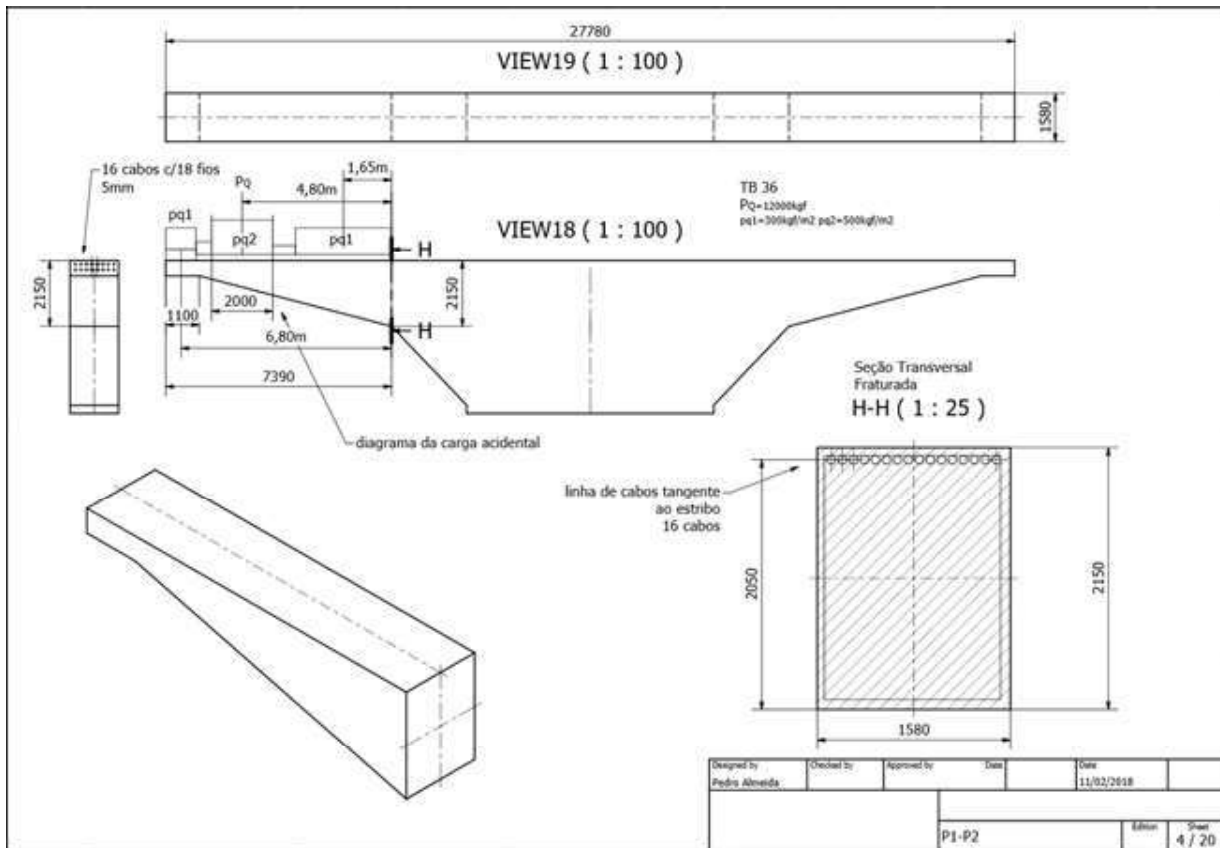
This information was amplified with the pictures, Figure 10, which were developed from the identifications of the parts of the structure after the dissection of fragments. The picture revealed relevant details of the broken parts in the collapse of viaduct.

3. Stage III, at this final stage, the deficiency of the corbel to resist vertical loads caused the behavior of the deck (slab) to be a shell (due to its 3 prestressed crossbeams, 2 of the ends and 1 of the middle), seeking its balance in the prestressed crossbeams. In this case, the crossbeam support in the P7 partially resisted transferring part of the vertical force to the corbel of the P7, which has a weak flexural strength due to the lack of typical armor of corbel.

Figure 10 - Lateral view of the P7 column, after fraction (schematic drawings), Source: Authors

Finally, the process is finished with the rupture of the cap beam of the wings span that propagated along the slab until the AP6.

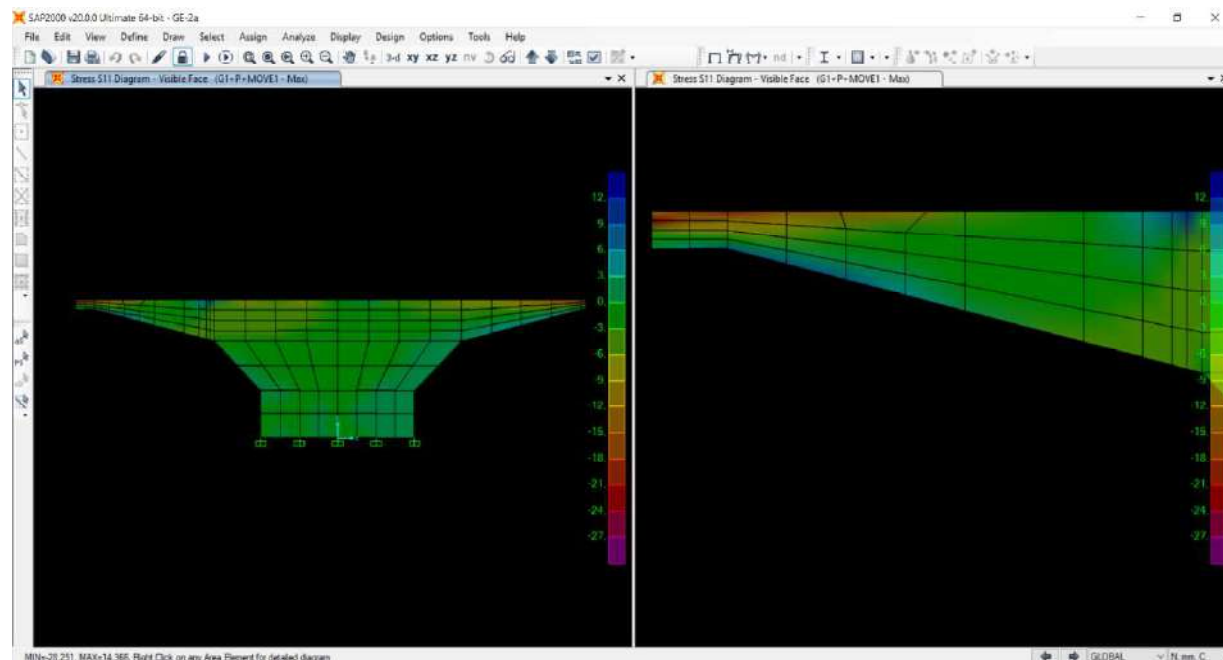
For the calculation of the stresses at the upper edges of the crosswise and bottom of the cross-section, it has combinations of tensile stresses at the upper edge of the order at 14.4 MPa and compressive stresses at the bottom edge of the order at 5.9 MPa. These values would require concrete with resistance above $FCK = 15 \text{ MPa}$ and complementary reinforcement on the upper edge of the support rail to resist tensile stresses at maximum load.

These values should be revised in the final version of the report, where the effective values of the resistances of the materials extracted from the structure will be considered. The results of the analysis of stresses resulting from the model of SAP (Structural Analysis Program), Figure 11.

Figure 11 - Results of finite element analysis, with prestressing P, permanent load G and accidental load vehicle Q TB36, voltage $S11 = + 14.37 \text{ MPa}$ at the top edge of the rail and $S11 = -5.97 \text{ MPa}$ at the bottom edge of the Corbel, Source: Authors
