The partial collapse of the Bridge Galeria dos Estados in Brasília, DF, Brazil

1 Abstract

The partial collapse of the Bridge *Galeria dos Estados* occurred on February 6th, 2018, in Brasília, Brazil when blocked the strategic traffic of downtown. Accessing the central bus station came to a complete stop, vitally impacting the commercial, banking and hospital sectors, and Government Administration District of the capital. The viaduct was built for the inauguration of Brasília, in February 1960, exactly 58 years ago. With 5,000 m², the viaduct has 8 spans with dimensions of 21.70 m and 27.0 m. The partial collapse of the viaduct suddenly occurred without large deformations, or other evidence visible to the naked eye, which could indicate, in advance, the fragility of the structure. The investigations indicated stress-corrosion on all prestressed cable the cap beam. The corrosion is systematic damage that occurs in all seven bent of the bridge. The structural retrofit of the bridge makes removals and reconstruction of the cap beam, easy for maintenance. Finally, the partial collapse could have been avoided if there was any visual inspection possibility, of reasonable cost, which wou

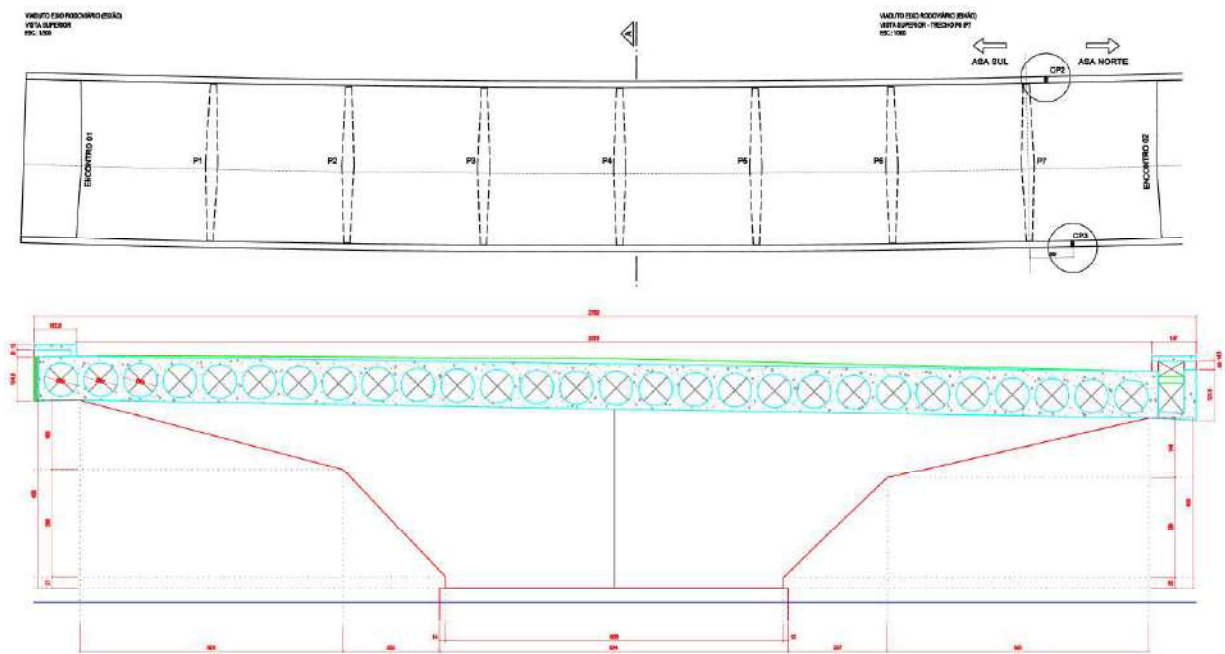
Figure 1. Top View and cross-section of viaduct, Source: NOVACAP, 2013

The collapse of the of the deck, approximately 7.0 m away, of the stretch supported on columns P6 and P7, on the east side, Figure 1.

The structural system of the bridge, it is described in Figure 1, and is based on a prestressed slab.

The viaduct was built with a structural system consisting of 8 alveolar slabs, with prestressed, isolated by expansion joints, over seven intermediate bents and two abutments E1 (south) and E2 (north). The support of the alveolar slabs in the encounters E1 and E2 are formed by GERBER beam, as the intermediate supports, Figure 2. The Intermediate supports are formed by 7 massive walled columns in the form of a "hang glider", with a wingspan of 27.0 m. The viaduct has a length between axles of bent approximately 22.1 m and 193.49 m length.

The deck is an alveolar slab with three transversal beams, whose dimensions are 1.05 m depth and 28 circular hollows of 80 cm in diameter, Figure 1.
